MEGUNTICOOK RIVER BASIN
CAMDEN, MAINE

SEABRIGHT POND DAM
ME 00277

PHASE I INSPECTION REPORT
NATIONAL DAM INSPECTION PROGRAM

AUGUST 1978

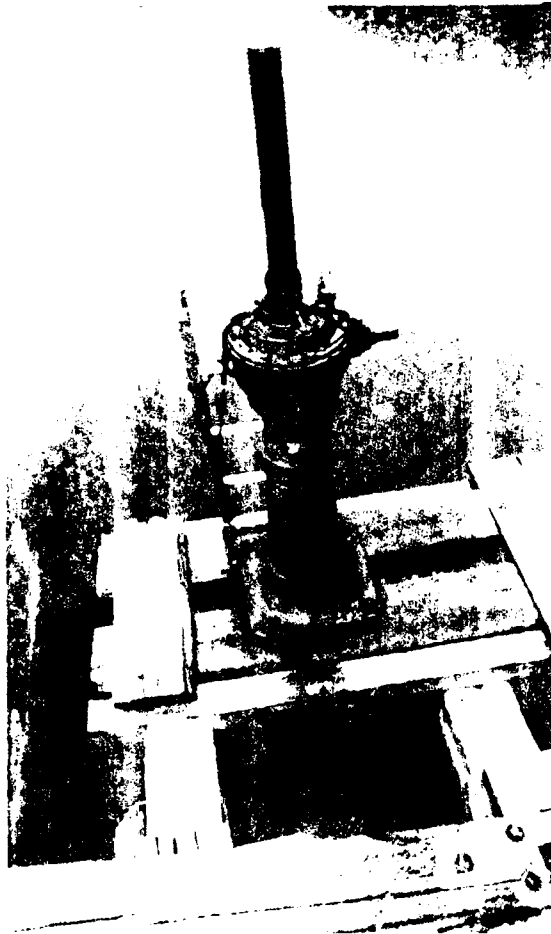
7

GATE OPERATOR

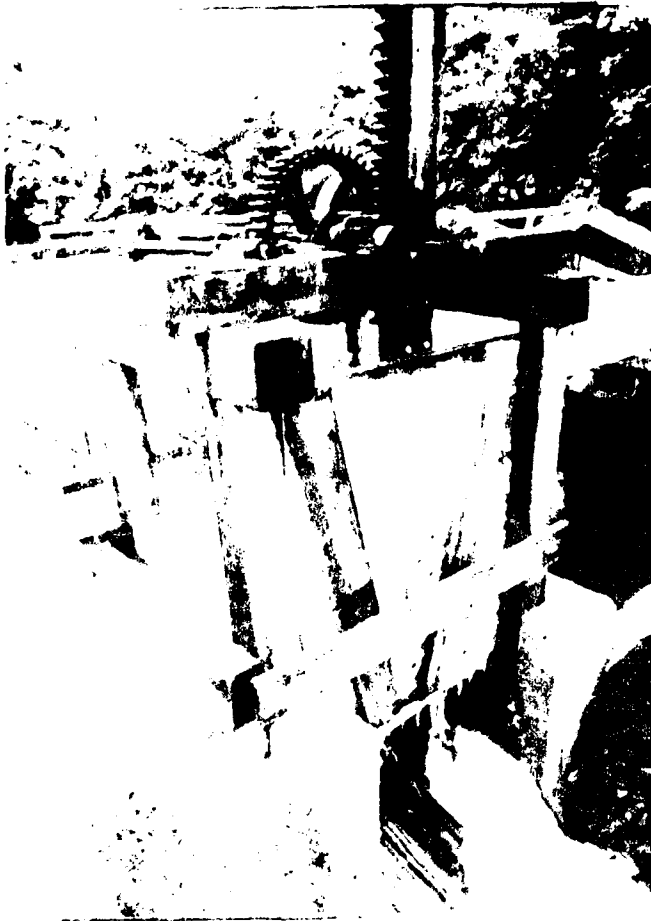
5

The spillway gate works consist of a vertical timber lift gate operated manually by a rack and gear. The works are in good mechanical condition. The gate stem has been spliced (apparently adequately) repairing vandalism to the gate works. See photograph 5.

2. Structural Cracking, Concrete. Cracks were observed in the lip of the spillway in several locations, all cracks appear stress related (see photograph 4). The upstream pier at the outlet works is badly cracked. The east training wall is badly cracked, see photograph 4. A large crack exists in the east wall of the generator room, and the dam crest is cracked west of the spillway gate. See photograph 5.

GATED SPILLWAY

5. Repair the crack in the concrete in the west spillway gate slide support.
6. Remove the diving board and ladder from the service bridge area of the dam.
7. The control bridge may act as debris collector during flood flows. Equipment and personnel should be made available to keep the spillway clear during flood flows.
8. Because the dam is upstream of populated areas and is subject to overtopping and subsequent distress, around the clock surveillance should be provided during periods of high precipitation or anticipated run-off (full spillway).
9. A formal warning system which could be used in the event of an emergency should be developed and implemented.
10. The dam should be inspected by a qualified engineer at least once every two years.
